## **hopkins home inspection**

### **Property Inspection Report**

1234 Your Pl, Portland, OR  
Inspection prepared for: John Smith  
Date of Inspection: 5/17/2022 Time: 9am

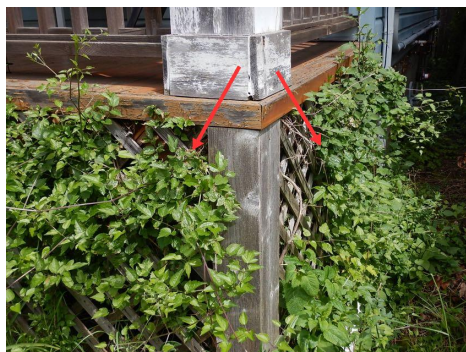
- Trees or plants were close to or touching the building. This can result in increased moisture or insect activity at the exterior walls or building. The vegetation needs to be cut away from the building, a minimum 6" separation is recommended.

Trim plants away

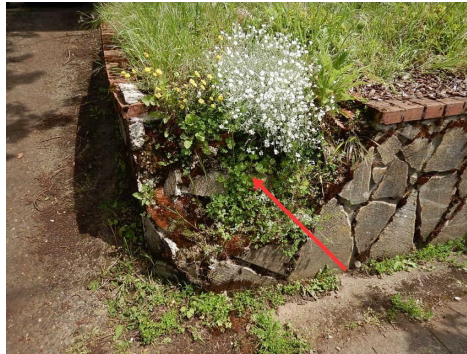
- **Large cracks were present at the wall and the wall may need repair or replacement, recommend further evaluation of the wall by a masonry contractor or professional engineer.**
- Portions of the wall were missing, repairs are needed.

Damage at wall

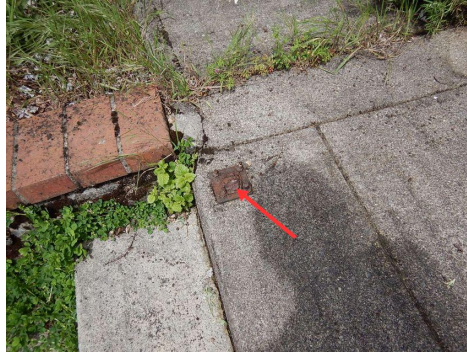
- **Trip hazards were present at the walkways, repairs are needed for safety.**

Trip hazards

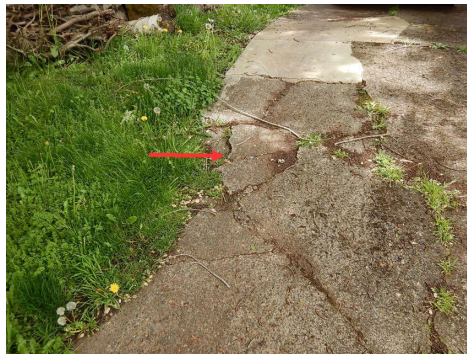
- Trip hazards were present at the driveway, repairs are needed for safety.

Trip hazards

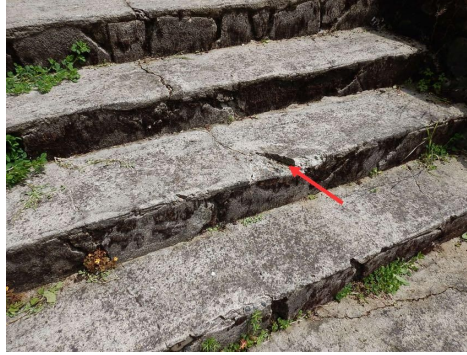
- Some stair treads were cracked and could be hazardous, recommend replacing the cracked treads.

Damaged treads

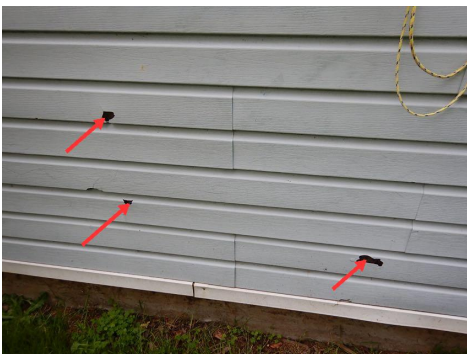
- Large cracks or openings were present at the siding or wall components. These opening need to be repaired or sealed.
- Areas of the siding were missing, repairs are needed.

Damaged siding

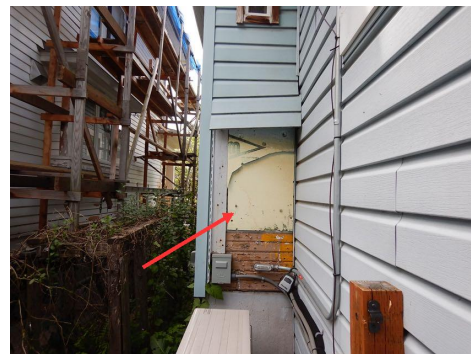
Missing siding

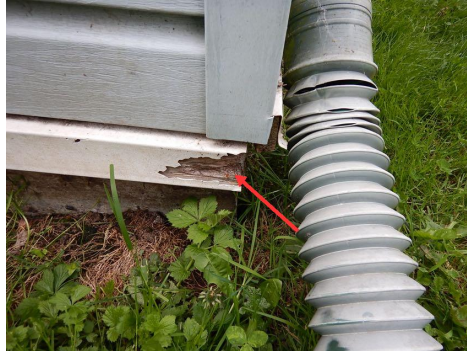
- Common cracks or openings were present at the trims or trim to wall transitions. These openings need to be sealed as part of routine maintenance.
- Moisture damage was present in areas, these areas need to be carefully monitored and are likely to need repairs.

Moisture damage

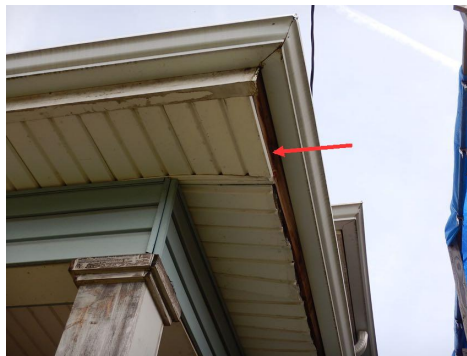
- There are large openings at the roof edge in areas, repairs are needed.

Opening at roof edge

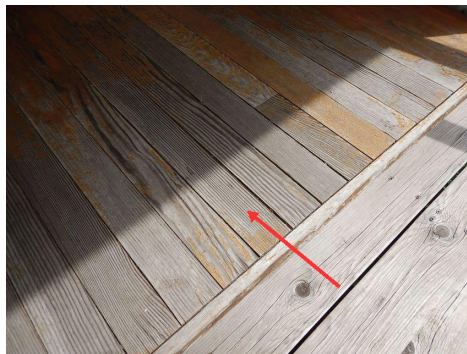
- Moisture damage was present at areas of the porch, this is an indication of the wear to the porch. These areas need to be carefully monitored and repairs or replacement are likely to be needed in the near future.

Moisture damage

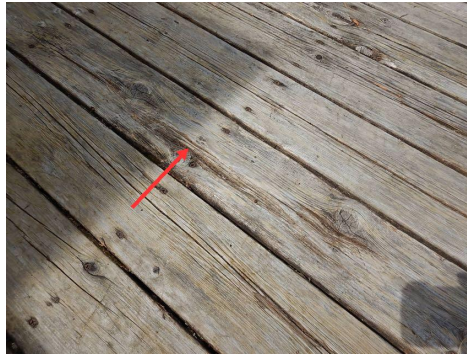
- Rot damage was present at areas of the deck. The rot damage needs to be properly repaired and may have affected the structural integrity of the deck. Recommend obtaining price estimates for the

needed repairs.

Rot at deck

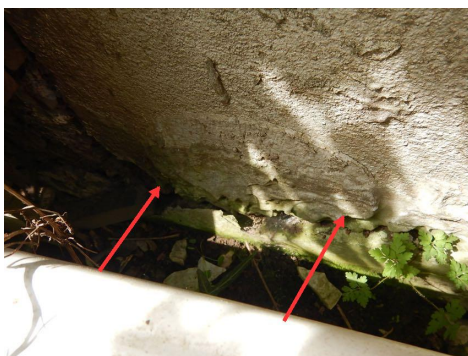
- Common deterioration was visible at areas of the foundation. Older foundations generally have some surface deterioration. This condition needs to be monitored and corrections or repairs may be needed if the deterioration continues.
- Patching or repairs were visible at areas of the foundation. This may be an indication of prior leaks or moisture at the foundation. Recommend further information regarding any prior leaks or water entry at the foundation. These areas need to be monitored and corrections may be needed if leaks or excessive moisture are present.
- The skim coat, or parge coat, at the interior foundation was deteriorated or separated in areas. This coat may be needed to help prevent deterioration to the foundation and repairs may be needed. Recommend further evaluation of this condition by a licensed foundation contractor.

Patching visible

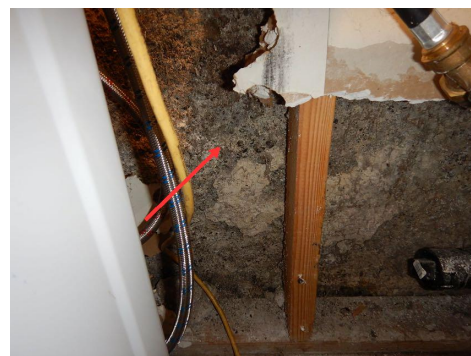
Deterioration and damaged parge coat

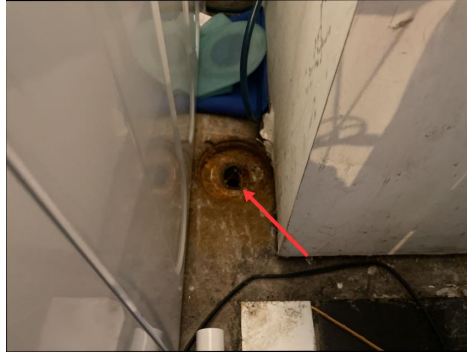
- Areas of the basement floor were covered or otherwise obstructed and were not fully visible for inspection.
- Stains were present at the floor drain area. Information regarding these stains and the operation

of the floor drain is needed. The stains at the drain area may be an indication that the drain backs up and the drain or drain lines may need to be cleaned or repaired.

Stains at floor drain

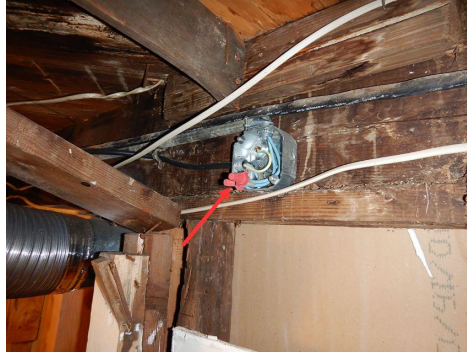
- Some junction box covers were missing, corrections are needed.
- Some of the visible wiring has been replaced with newer type wiring. Recommend verifying building department permit and inspection records for this work.

Missing box cover

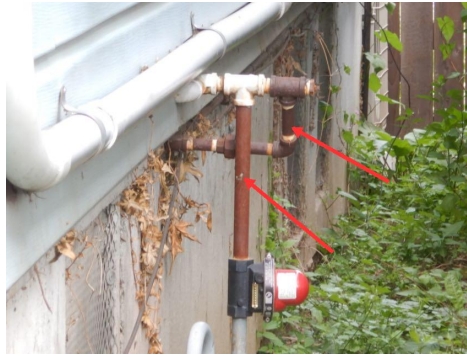
- Some exterior gas lines were not corrosion protected. Corrosion inhibiting paint needs to be applied to all exterior iron or steel gas lines.

Pipes not protected

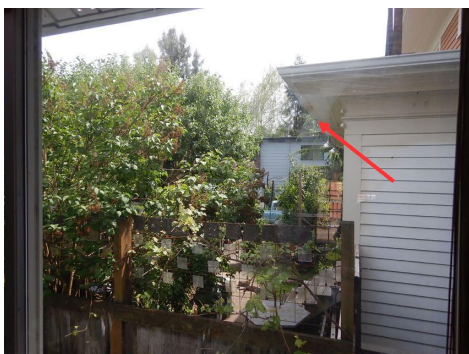
- Some window locking hardware was missing or damaged and needs to be repaired or replaced.
- Some double paned windows appear to be fogged or have moisture present between the pieces of glass. The seal between the glass appears to be damaged. The glass at these windows needs to be replaced.

Fogged glass

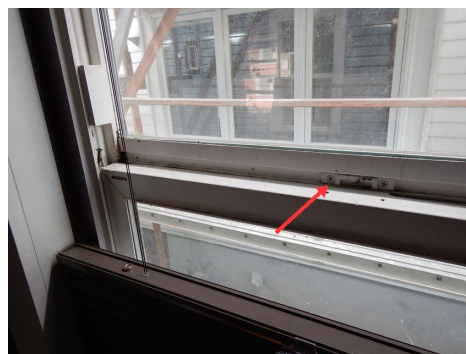
Missing locks

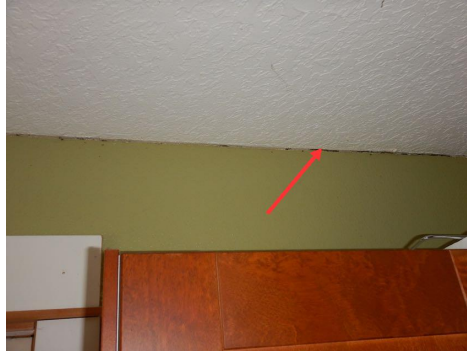
- Typical cracks visible, these type of cracks appear to be common.

Cracks at walls

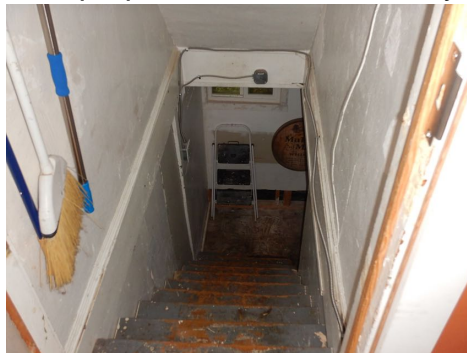
- No hand rail installed, need to install proper hand rails for safety.

No railing present

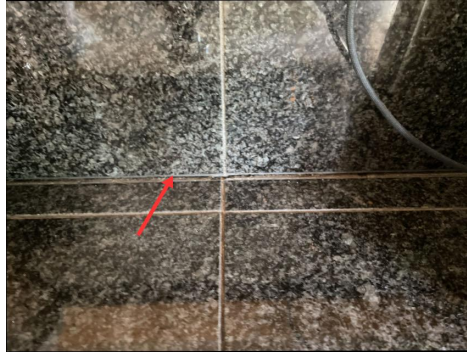
- Most areas of the counters were covered with items and were not visible for inspection.
- Caulking or sealing is needed in areas.

Seal transitions

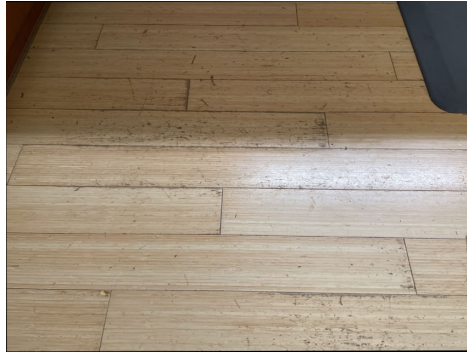
- Heavy wear to the flooring.

Heavy wear at floor

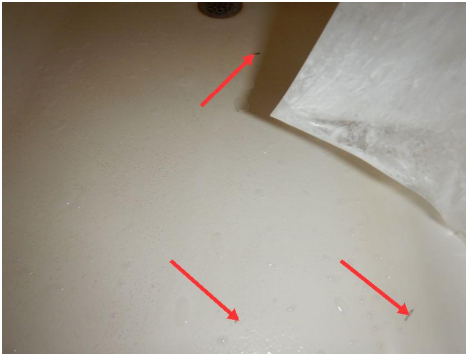
- Need to seal the tub spout and control valves to the wall.
- The tub finish was chipped.
- Shower head: A hose was installed at the shower head, this is a potential source of cross contamination to the clean water supply. A anti siphon type valve needs to be installed at the shower hose.

Tub chipped

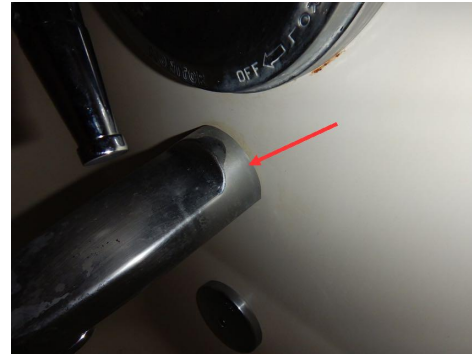
Seal spout

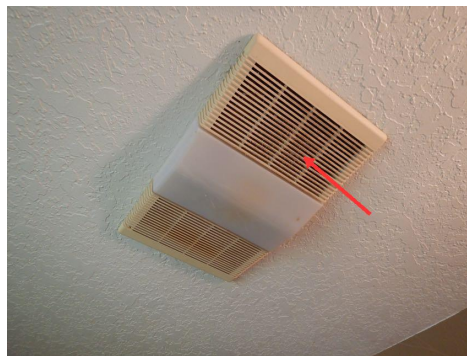
- The fan was dirty and needs to be cleaned.

Dirty fan

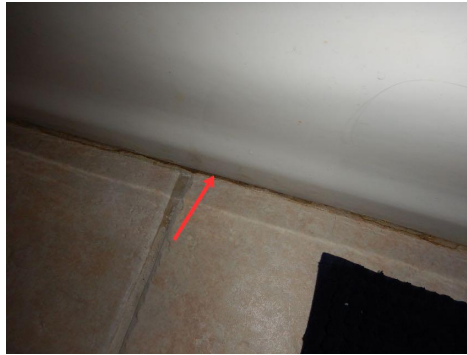
- The transition between the floor and tub needs to be caulked or sealed.

Seal transitions

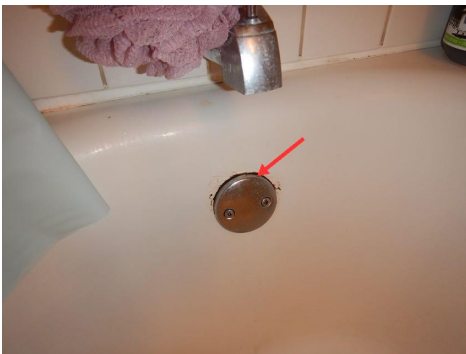
- Recommend new caulking at tub area transitions.
- The tub enamel was worn.
- Shower head: A hose was installed at the shower head, this is a potential source of cross contamination to the clean water supply. A anti siphon type valve needs to be installed at the shower hose.
- The tub was rusting in areas, repairs are recommended.

Rust at tub

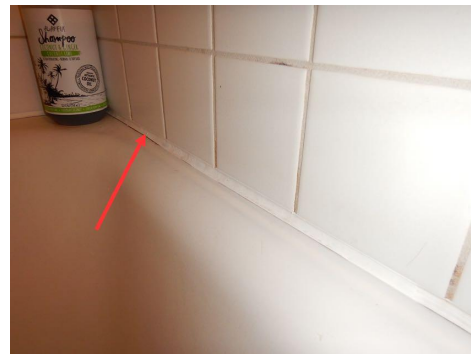
Seal transitions
